# Avionics Box Cold Plate Damage Prevention

Damon B. Stambolian  
NASA Kennedy Space Center (KSC)  
Engineering and Technology Directorate  
JFK Space Center  
KSC, FL 32899  
321-861-5973  
[damon.b.stambolian@nasa.gov](mailto:damon.b.stambolian@nasa.gov)

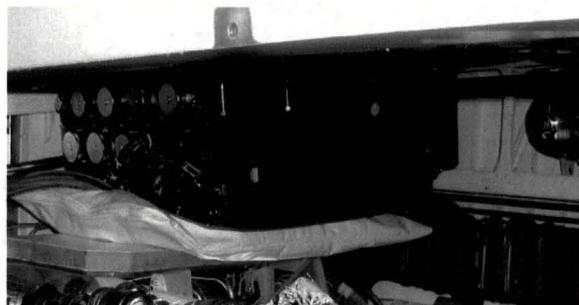
**Figure 8 Air Bag Method**

The airbag method utilizes an inner tube enclosed in a bag along with associated hardware. The box is still manually lifted into the opening, but the airbag aids in lower/lifting the box to the cold plate. This method is only useful on LRUs that hang under the shelf. The Airbag must be checked before use for operation and lifting capability. The airbag is inflated to lift the LRU to the receiving cold plate surface during installation, and deflated to lower the LRU away from the cold plate during removal. The potential causes of damage are uneven contact of the LRU to the cold plate if the LRU mating surface does not remain parallel with the cold plate during lifting, and incidental damage to flight hardware that supports the weight of the LRU on the airbag. Unexpected LRU movement during fastener removal is another potential cause of damage. The air bag should fully support the LRU. See Figure-8
